Pedestrian Accessibility Scan – Site Visits

Overview

Elmwood Avenue – Hollywood Avenue to Continental Drive, Brighton, NY

Monroe Avenue – Hollywood Avenue / Rhinecliff Drive to Continental Drive, Brighton, NY

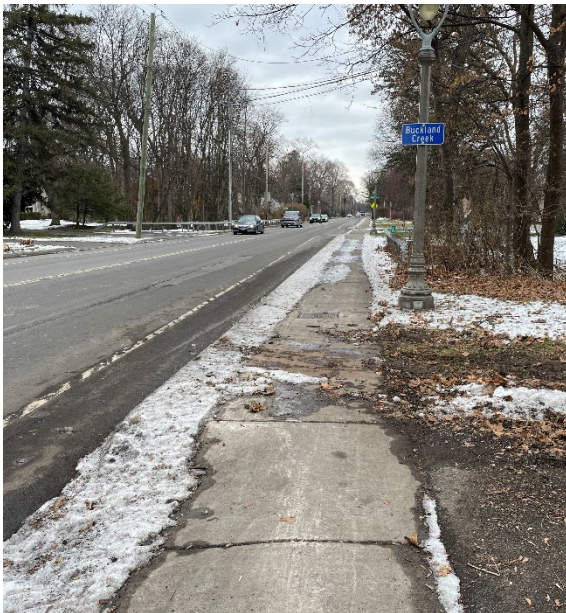
- **Elmwood Avenue, south side, between Monroe Avenue and Continental Drive:**
 - Pavement condition is generally good. Minimal buffer space/snow storage space.
 - A few slabs in vicinity of Exxon station have heaved more than 0.5" (ADA non-compliant)
- **Twelve Corners intersections:**
 - No Leading Pedestrian Intervals (LPis) observed at any of the crossings.
- **Elmwood Avenue and Hollywood Avenue Intersection:**
 - Push buttons and countdown signals are present.
 - Ice and debris have accumulated at curb ramps, reducing accessibility.
 - Tactile warning strips are in poor condition.
 - Crosswalk markings and stop bars across Elmwood Avenue are in poor condition.

Sidewalk Surface Condition near Buckland Creek

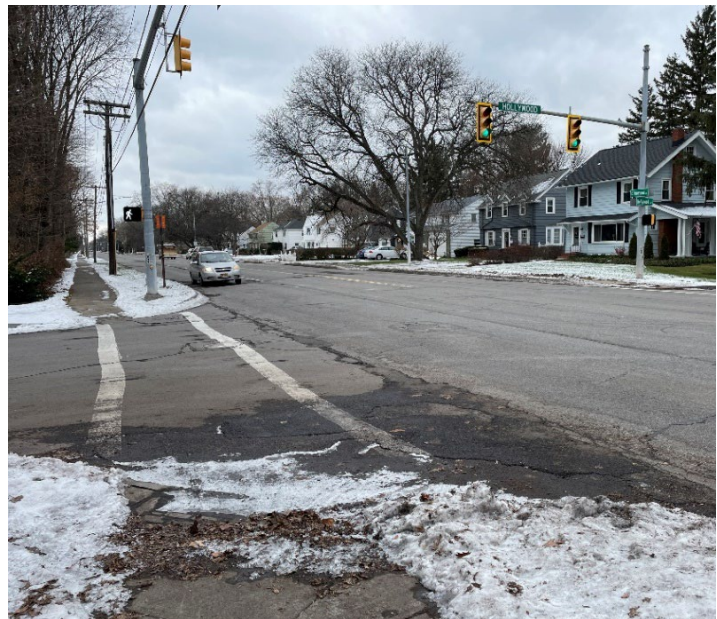
Elmwood Avenue and Hollywood Avenue Intersection

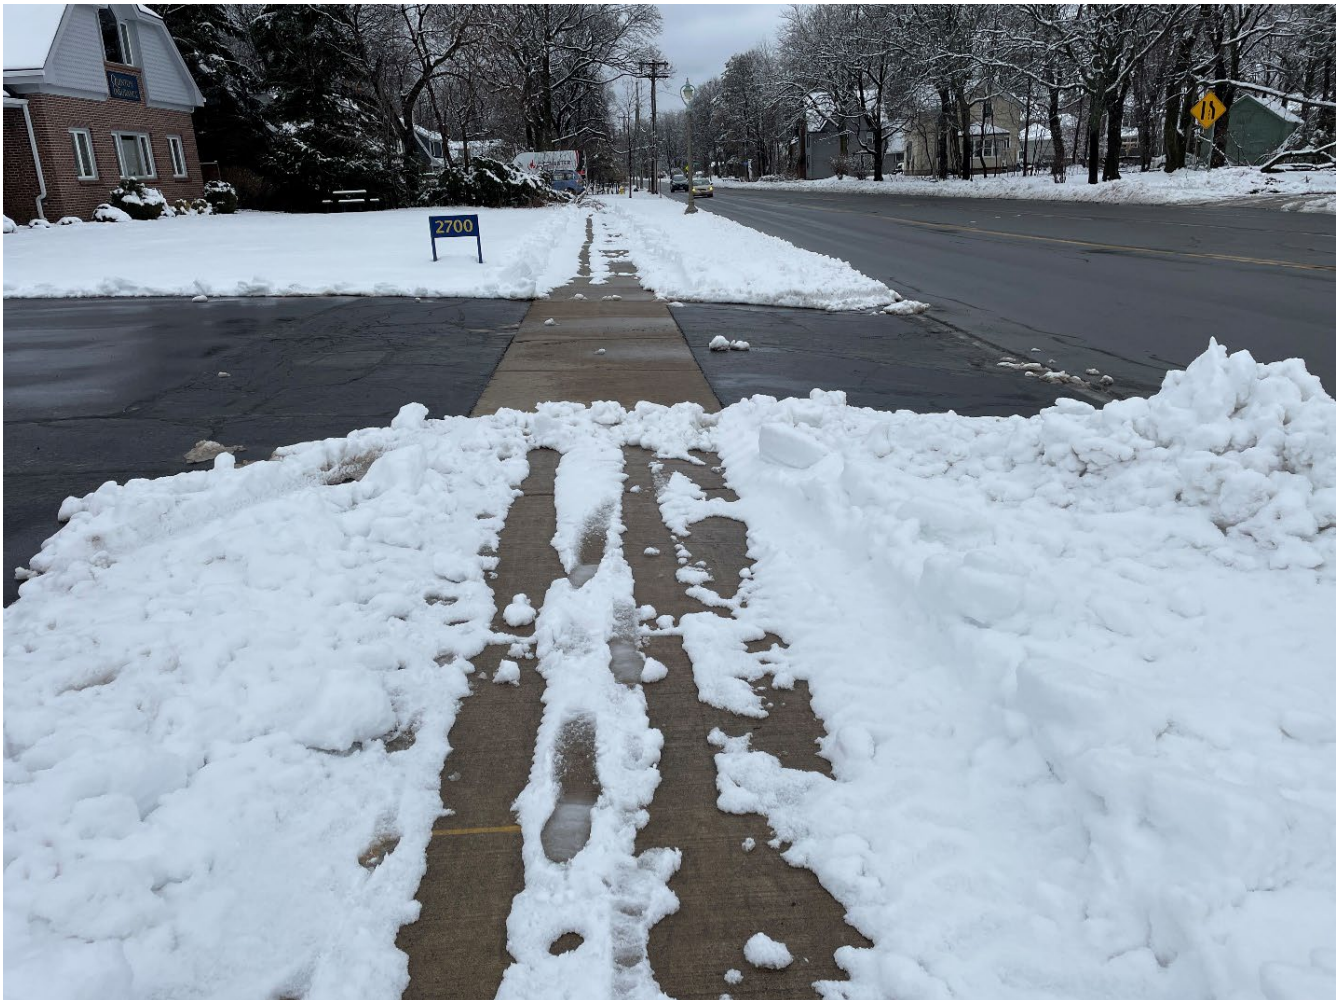
2700 Elmwood Avenue

- **2700 Elmwood Avenue:**
 - 75% +/- cleared. Uncleared snow presents an obstacle for wheelchair users.

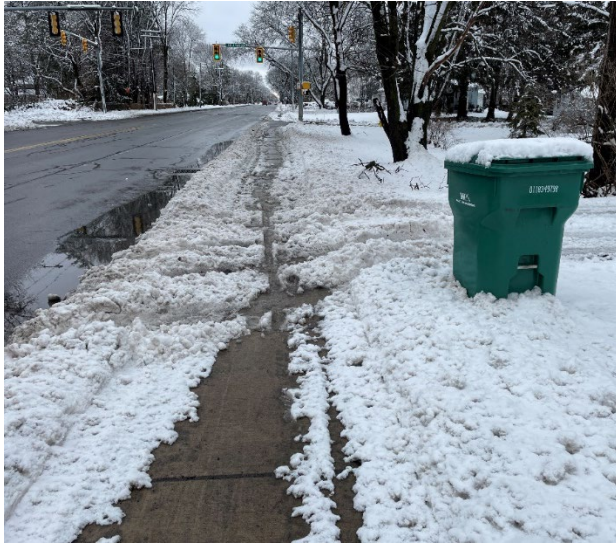
- **Northside of Elmwood, west of Winton Rd:**
 - Sidewalks 50-60% +/- cleared, 1" +/- of slushy material is a challenge for lower mobility levels.
- Residential driveway east of Hollywood is not cleared, blocking passage on Elmwood sidewalk.
- Elmwood & Hollywood intersection: poor conditions on southeast corner: 6" plus snow blocking curb ramps, poor drainage, and some standing water. Impassable for lower mobility levels.

Residential Driveway on Elmwood east of Hollywood Elmwood & Hollywood Intersection

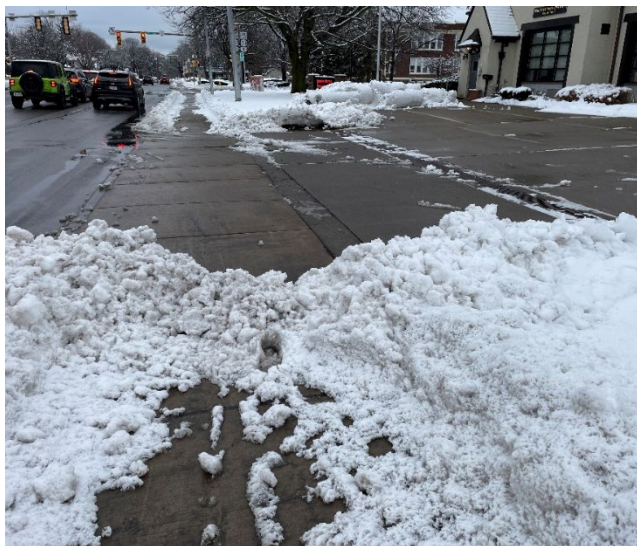
- Fire Station # 2: Driveway has been cleared, but plowed snow creates barriers to passage on Elmwood Ave sidewalk.
- South side sidewalk by Middle School: poor drainage and road splash onto sidewalk (insufficient buffer zone and snow storage space.)

Fire Station #2

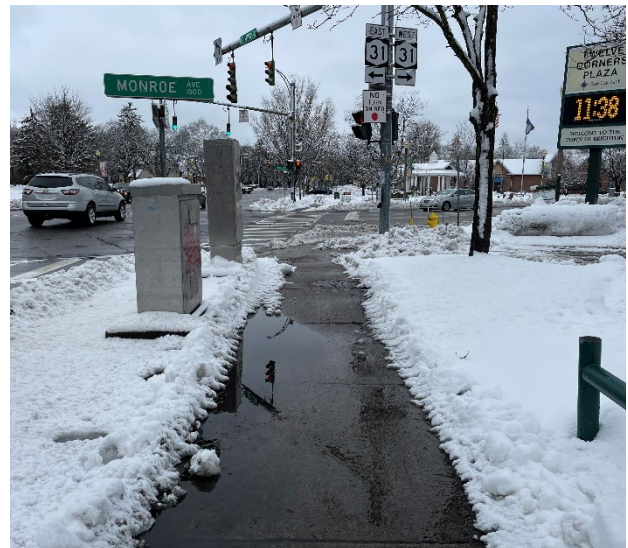
Ponding at 12 Corners

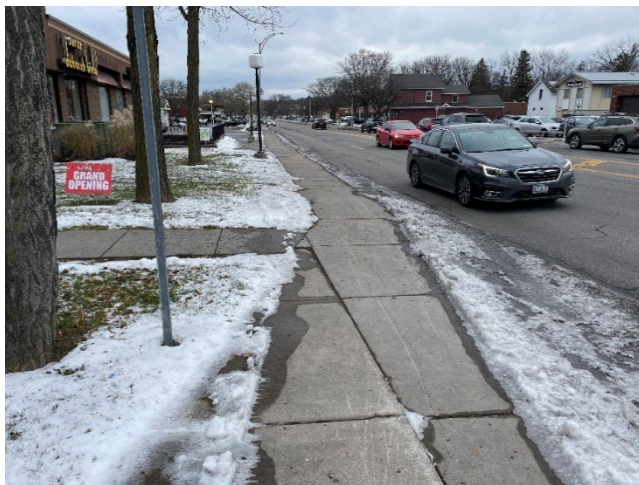
- Sidewalk pavement is in generally good condition.
- Sidewalks adjacent to curbs (no buffer zone or snow storage space).
- Four lanes of traffic with high volumes (9,617 – 10,321 vehicles daily on average based on 2019/2020 counts)
- Note pedestrian light post missing a lamp.
- North side of Elmwood, Bus stop shelter at 12 Corners, snow plowed from sidewalk is obstructing access into the shelter
- Turning radius at Monroe Avenue and Rhinecliff Drive creates a long crossing distance (approximately 60 feet) for pedestrians
- Land use impacts on Walkability around 12 Corners:
 - Two Gas stations in this area have 40-50 foot curb cuts and high-volume vehicle circulation
- Note: Pervious concrete installed along Monroe Avenue shows less icing than standard concrete sidewalks.

Sidewalk adjacent to roadway

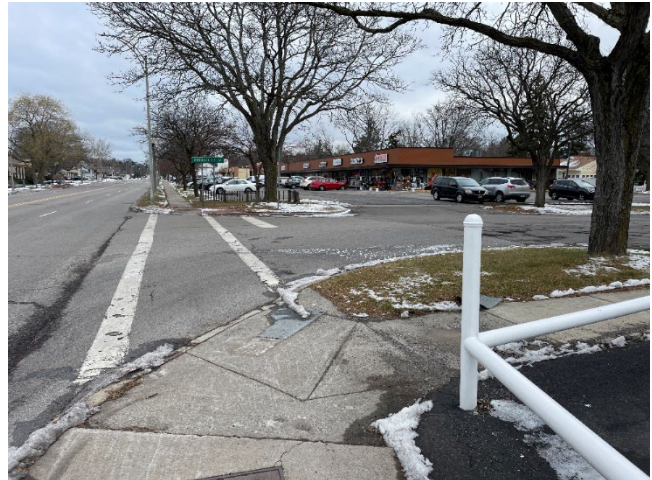
60-foot crossing distance at Rhinecliff Drive

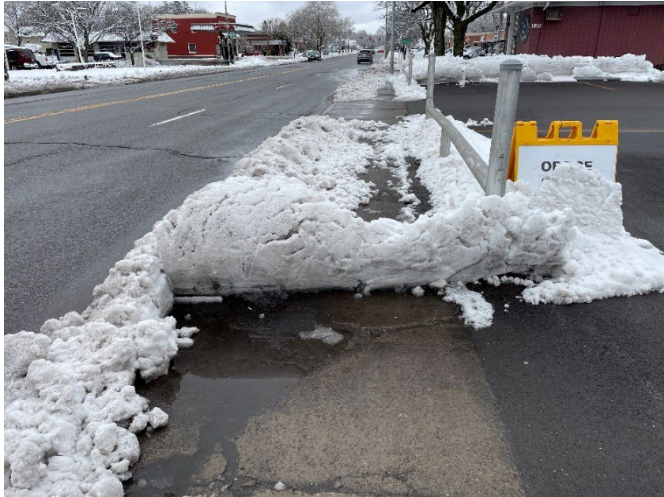
- **East side of Monroe Ave. at Sunoco gas station:**
 - Sidewalk 90% +/- covered by 2"+ of snow.
- **Monroe Ave, from Hollywood Ave/Rhinecliff Dr to Continental Dr:**
 - Sidewalks 75% +/- covered by 2"+ of snow and slush.
 - Ponding on roadway present resulting in road spray onto sidewalk in several locations.

Plowed snow blocking sidewalk at Sunoco Gas Station

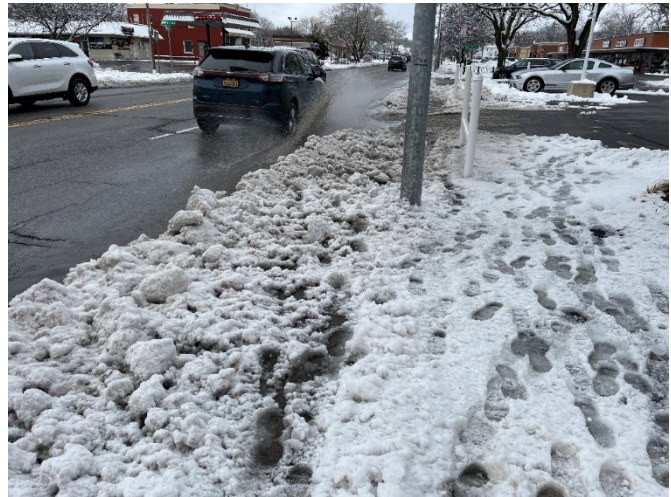
Unplowed Sidewalk on east side of Monroe north of Twelve Corners

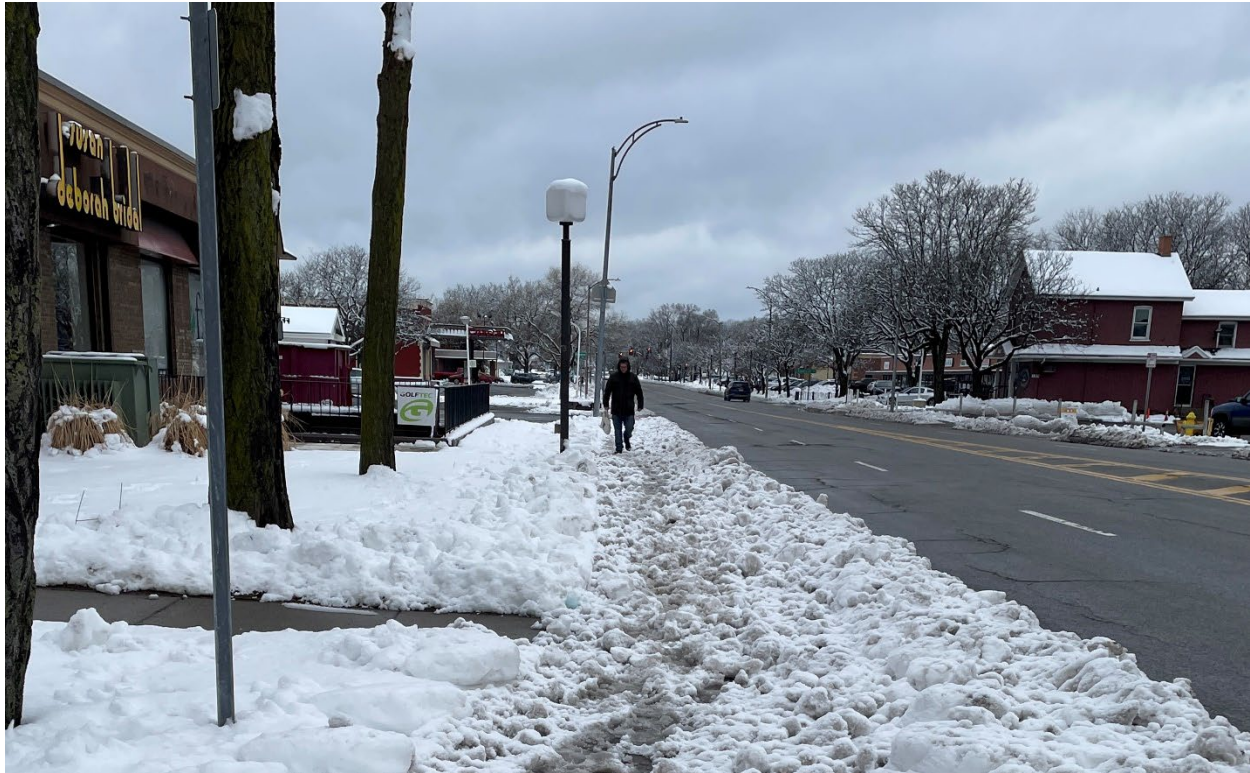
Unplowed sidewalk on the west side of Monroe Avenue north of Twelve Corners

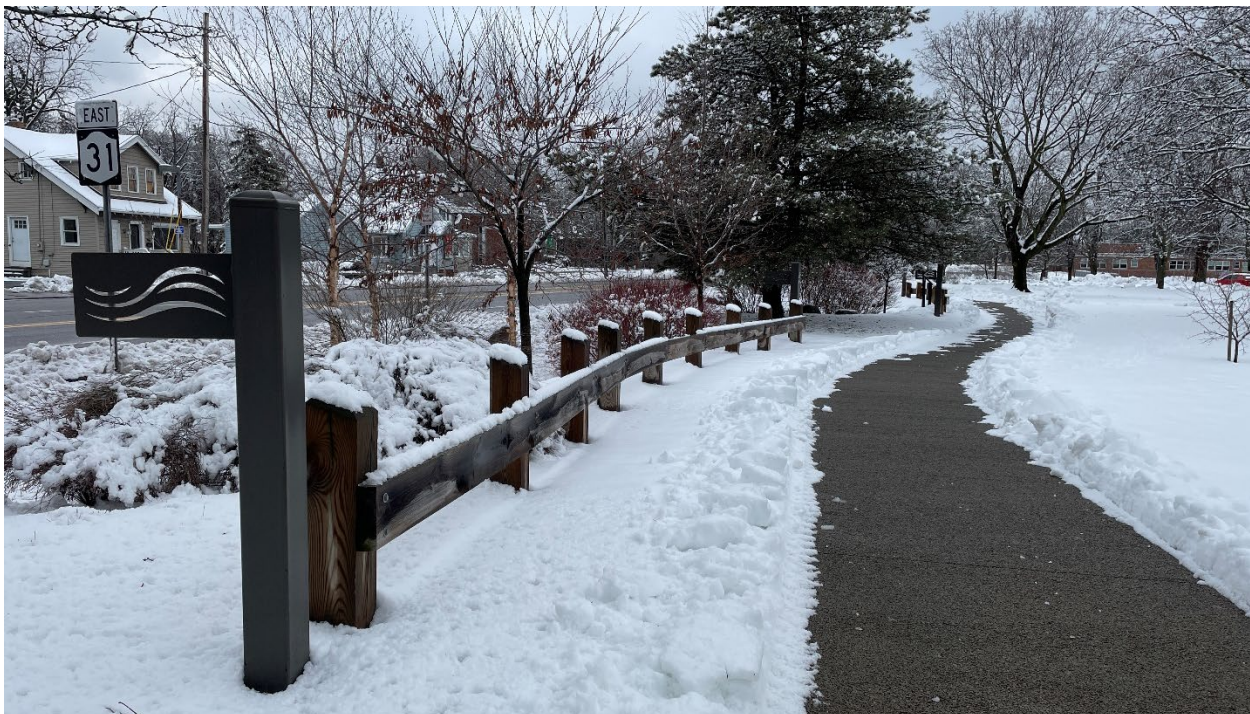
Clear permeable pavement on side path along Monroe Avenue at Twelve Corners Middle School

NOTE: Permeable concrete sidewalks, west side of Monroe at Middle School, are in very good condition and completely free of snow and standing water. Minimal or no salt was observed along this section of sidewalk.

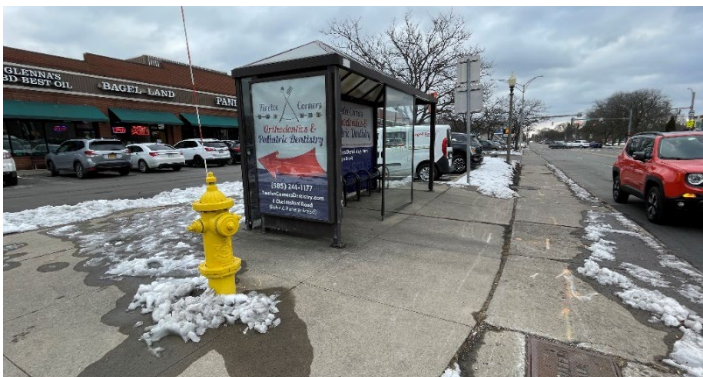
- Pedestrian signals are present, but there are not countdown timers or Accessible Pedestrian Signals.
 - RTS bus stop at this intersection has a shelter with benches and adequate concrete snow storage area.

Bus Stop at Winton Road & Monroe Avenue

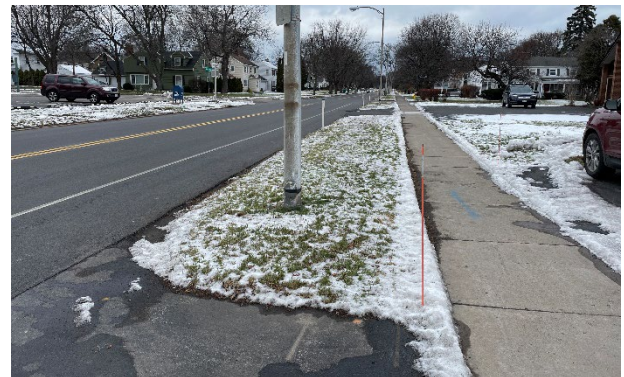
- **Winton Road, between Chelmsford Road and Varinna Drive**
 - Tree lawn is present which provides some spatial buffer for pedestrians
 - No street trees are present.

Tree Lawn on Winton Road with no street trees

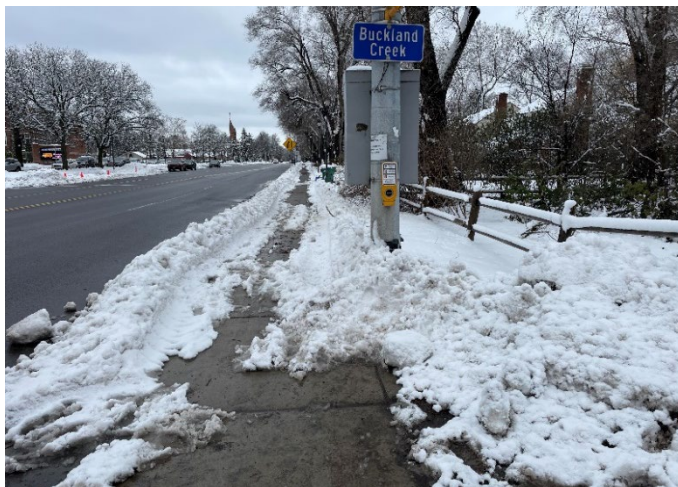
- **Winton Rd., west side, south of firehouse: Sidewalk is less than 50% +/- cleared.**
 - Only a narrow footpath is walkable, not ADA compliant.
- **1037 Winton, Kessler Center:**
 - Sidewalks 50-60% +/- cleared, not ADA compliant.
- **Winton Rd, east sidewalks, adjacent to Middle School:**
 - 2"+ snow and slush, potential icing
- **Winton Rd.,east side, crossing Elmwood:**
 - Snow pile from plowing blocking more than 50% +/- of crosswalk.
 - Access to pedestrian button is blocked.
- **Winton & Chelmsford:**
 - Sidewalks more than 50% +/- blocked by slush and snow.
 - Ponding from poor drainage evident at both sidewalk ramps.
- **Winton & Penarrow Rd:**
 - Poor conditions at both sidewalk ramps
 - More than 50% +/- blocked by snow, slush and standing water.

Partially cleared sidewalk at Buckland Creek

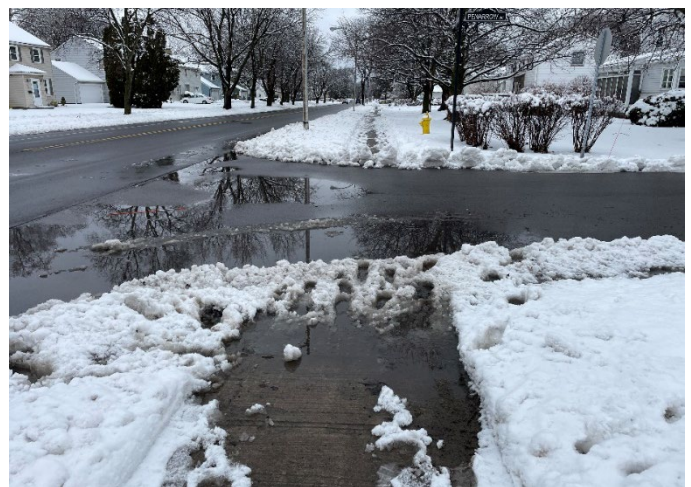
- Ponding is present at curb ramp at Winton Road and Penarrow Road and could result in icing problems .

Snow obstructing sidewalk ramps at Penarrow Road

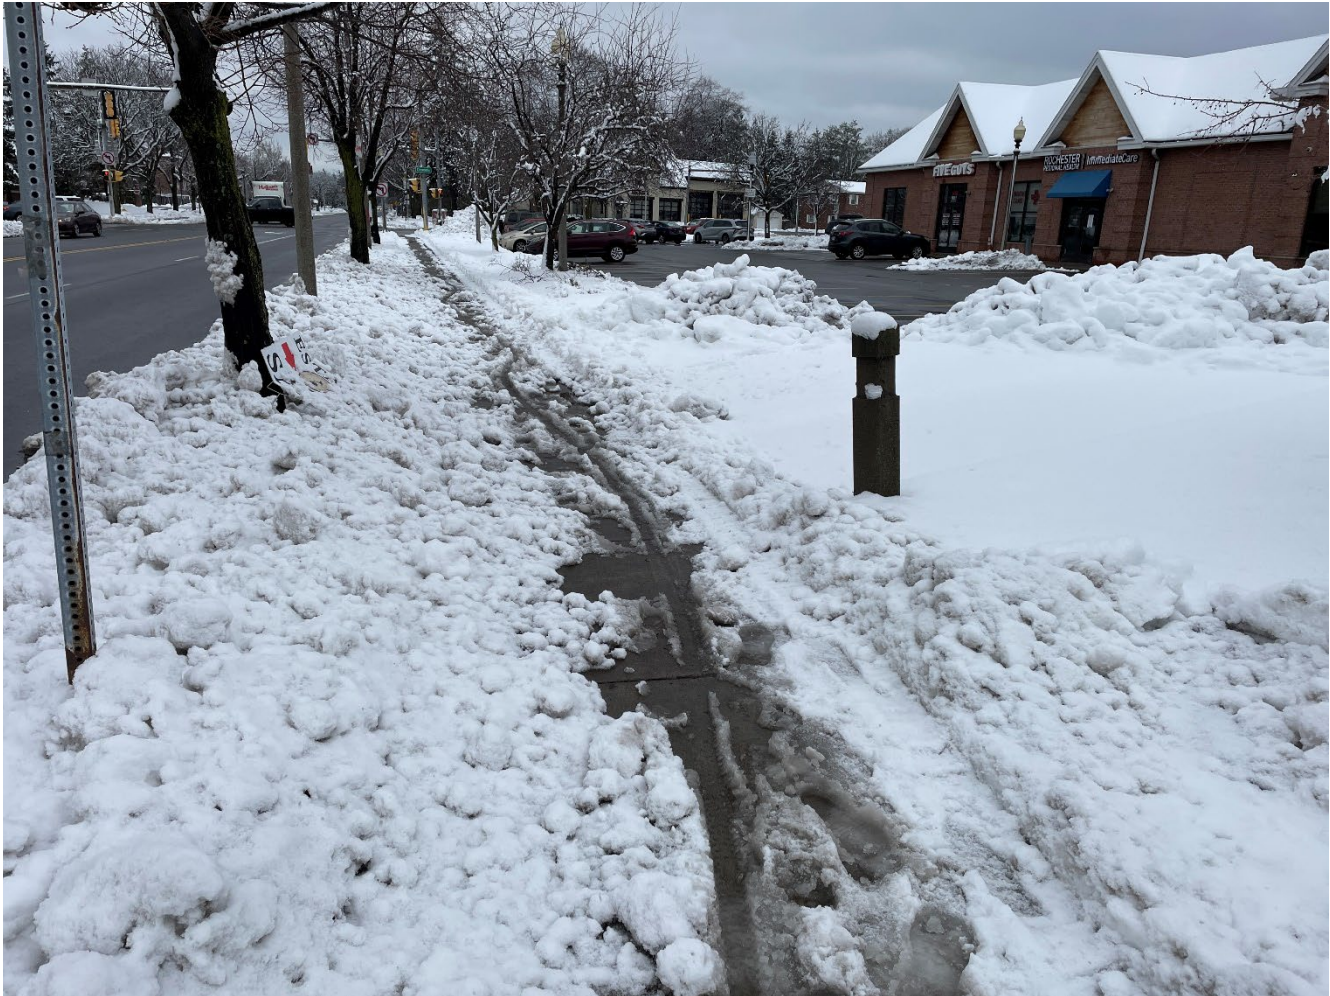
Partially cleared sidewalk on west side of Winton Avenue.

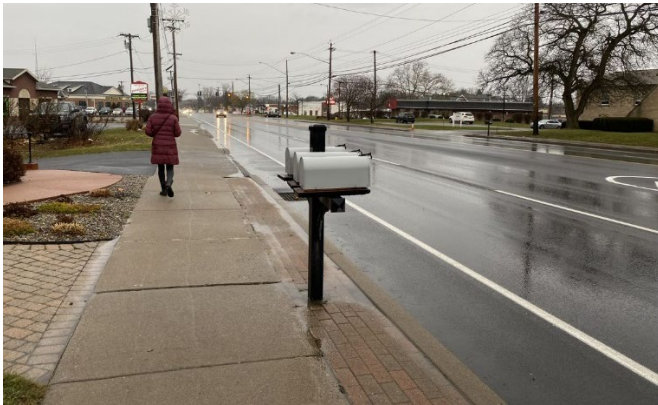
Sidewalk on South Side of Chili Avenue

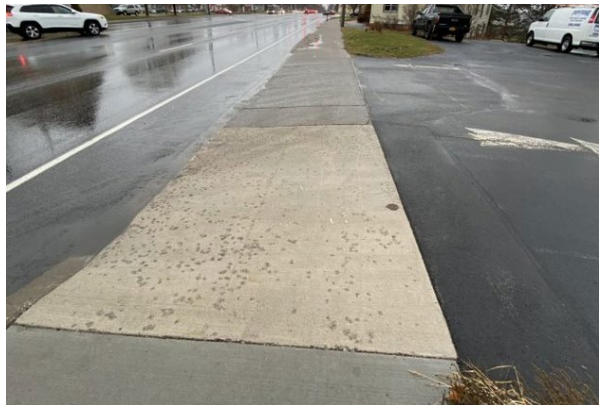
- The sidewalks were icing over due to freezing rain.
- Sidewalks became part of driveways, creating a sloped surface for pedestrians.
- Cars were observed stopping close to pedestrian crosswalk line. A stop bar was present.
- There is a bus station with a shelter, and two without a covered shelter.
- Curb ramps were generally in good condition.
- Crosswalk markings were generally in good condition.
- Pedestrian signals were generally in good condition.
- Pedestrian push buttons were in working condition.
- Sidewalks were generally in good condition.

Sidewalk along driveway

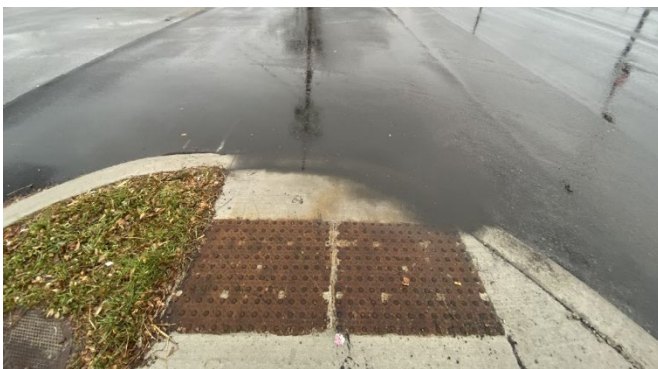
Pooling water at curb ramp

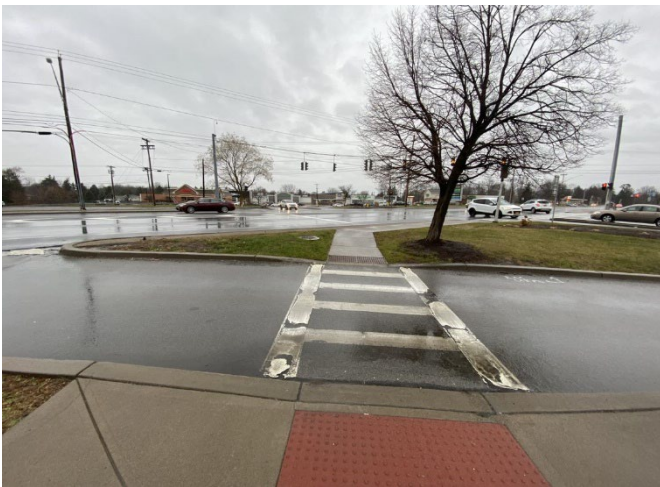
Crosswalk across slip lane to pedestrian island

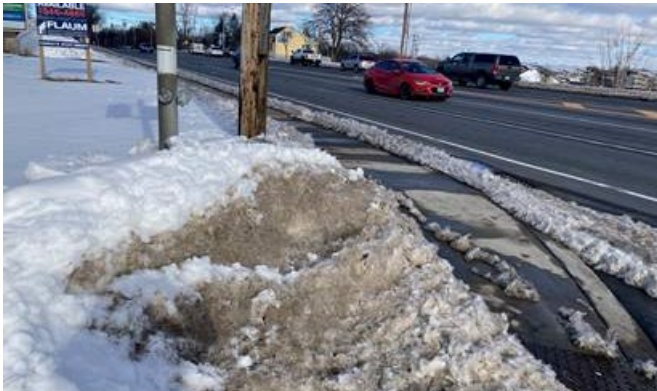
- The walkways were cleared of snow, but small portions of the sidewalks had slushy snow, especially near the curbs.
- Commercial driveways were cleared of snow.
- Walkway have been plowed within 12 hours after snowfalls; snow piles accumulated near the crossing and block the access to the pedestrian push buttons.
- Curb ramps were generally in fair condition (some slushy snow accumulations).
- Crosswalk markings were generally in good condition.
- Pedestrian signals were in working condition.
- Sidewalks were generally in good condition.

Snow block the access to the signal button and the curb ramp

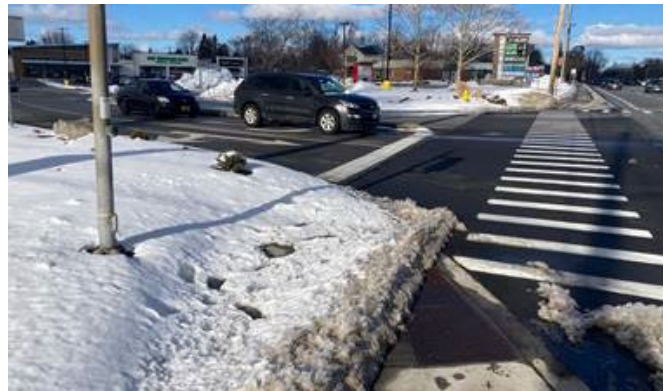
Snow clearing missed the curb ramp

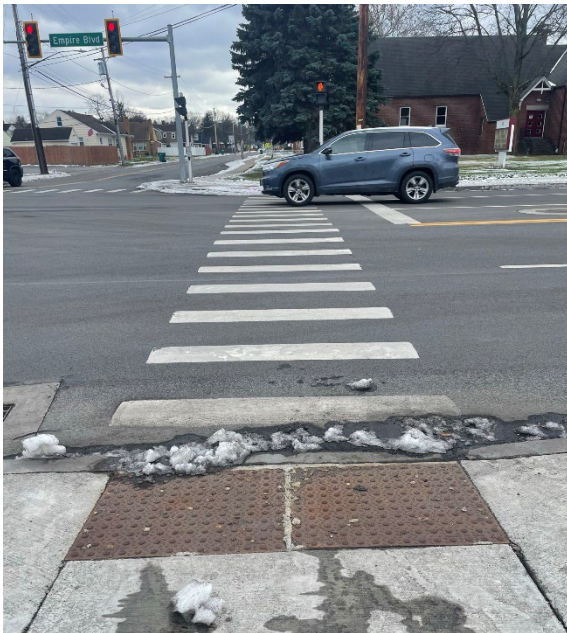
- There is an Accessible Pedestrian Crossing with voice assistance at the intersection of Empire and Helendale.
- The detectible warning strips are beginning to degrade at the Helendale intersection.
- The sidewalks were recently constructed, and are in excellent condition.
- There is very little cracking or heaving along this segment.
- Crosswalk striping is not present on side street approaches with stop control.
- There are some young street trees along the corridor (newly planted with roadway conversion project).
- Vehicle traffic is heavy (11,978 vehicles daily on average based on 2019 counts)
- There is a tree lawn buffer between pedestrian traffic and the roadway.
- There is a pedestrian signal at the Culver Road intersection.
- The parking lot at Dan's Crafts & Things directly abuts Empire Boulevard. The parking is continuous along the roadway, and there is a 144 foot curb cut.

Crossing at Helendale Road

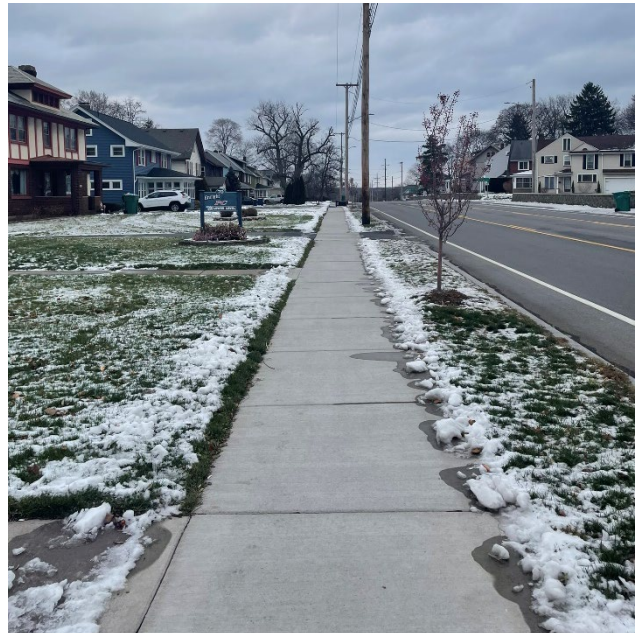
Excellent pavement condition and new street trees

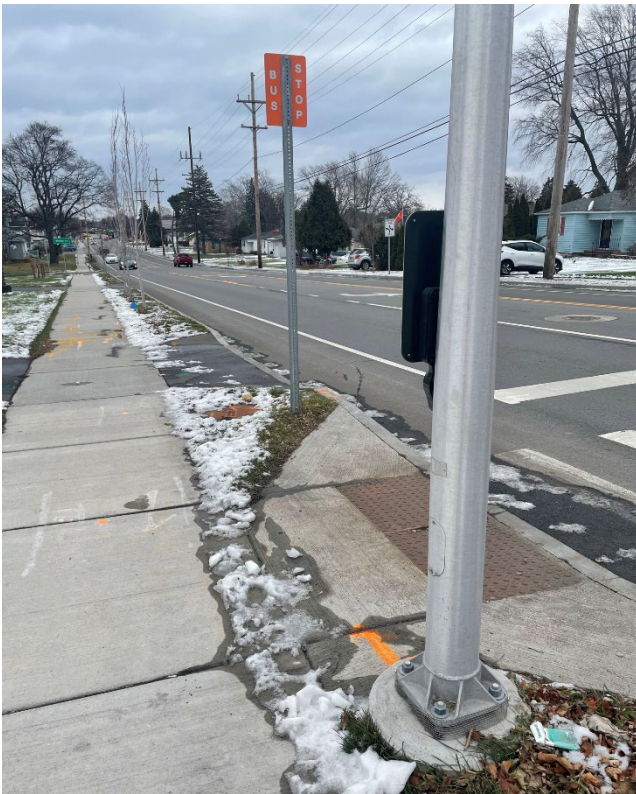
Bus Stop at Shelford Road is not ADA accessible.

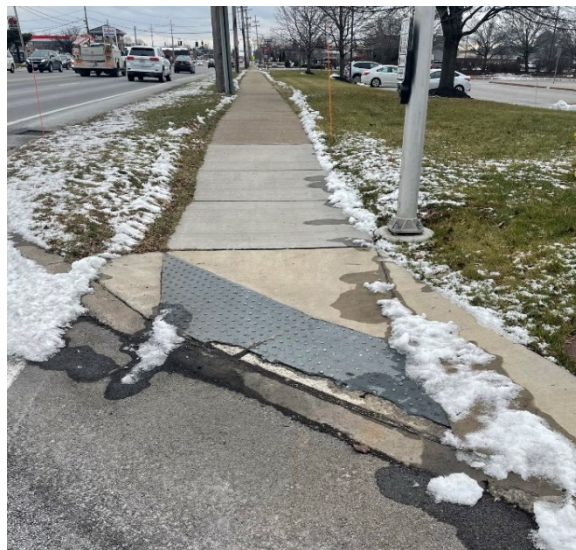
- There is some debris and the detectable warning strip is beginning to degrade at Brandt Point Drive and at the Wegmans Driveway.
- There is a pedestrian signal with voice assistance at the crosswalk at the intersections Wegmans driveway, and at Creek Street / Bay Road.

Detectable Warning Strip at the Wegmans Driveway

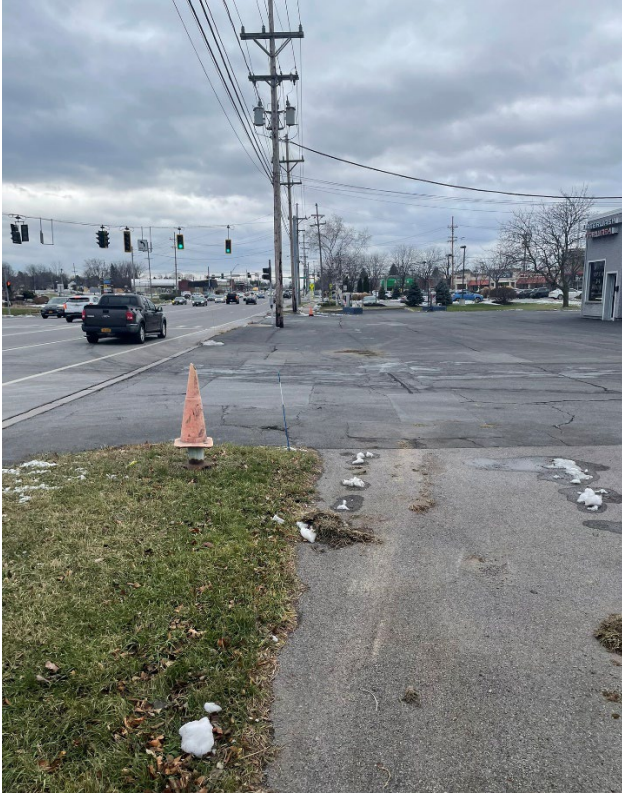
- There are 30 curb cuts along this segment
- A sidewalk is not present in front of the Laser Wash Car Wash. There are two curb cuts, both approximately 40 feet in width.

Laser Cash Car Wash – No sidewalks present

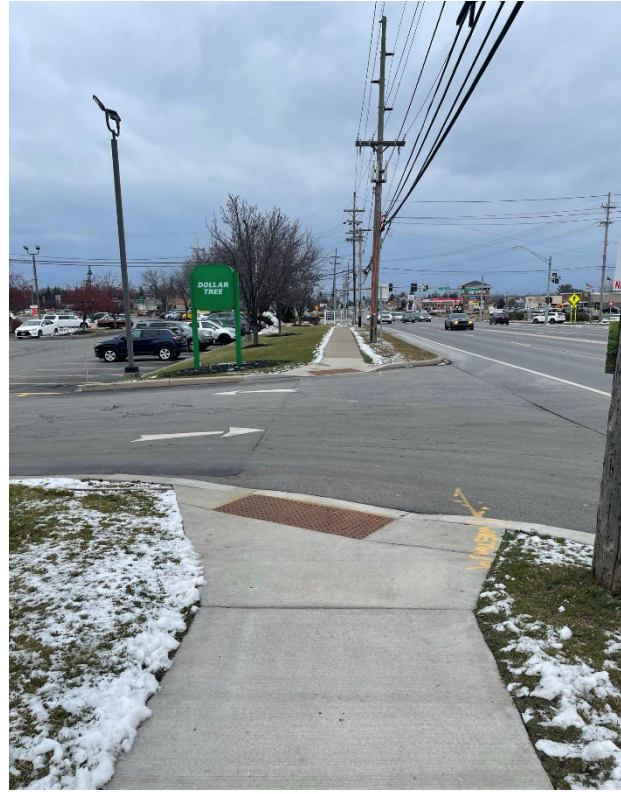
No crosswalk striping at Dollar Tree curb cut

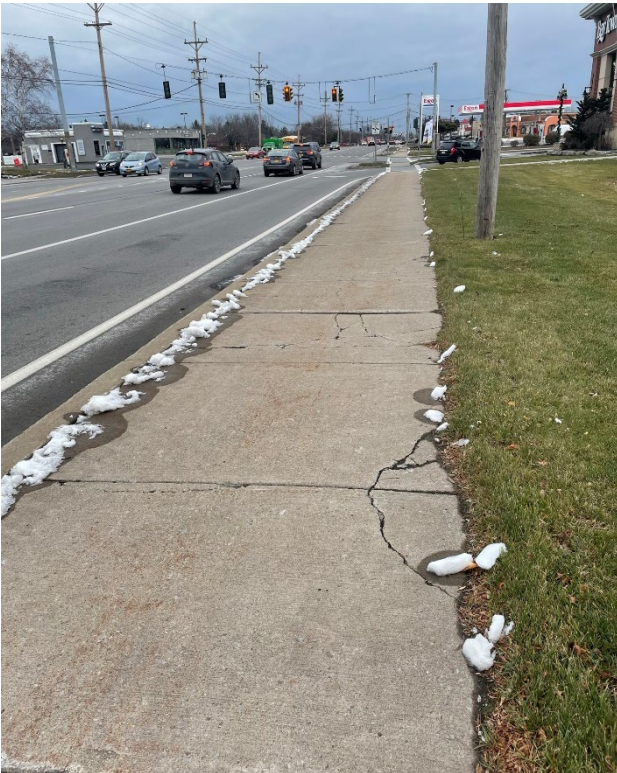
- There is a 30 second crossing time at the Creek Street / Bay Street intersection.
- There is some minimal cracking on the sidewalk, but the surfacing is generally in good condition for the entirety of this roadway segment.

Some cracking on sidewalk

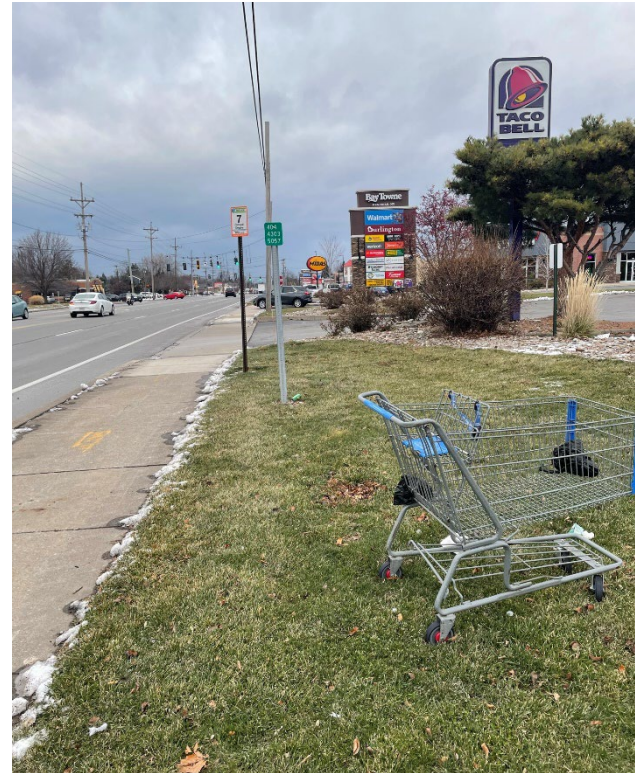
- The sidewalk is adjacent to the roadway on the east side of Empire between the main access drive to BayTowne Plaza and Creek Street.
- The bus stop on the east side of Empire Boulevard between Creek Street and Brandt Point Drive is not ADA accessible, and there was a shopping cart left at the bus stop.

Bus stop

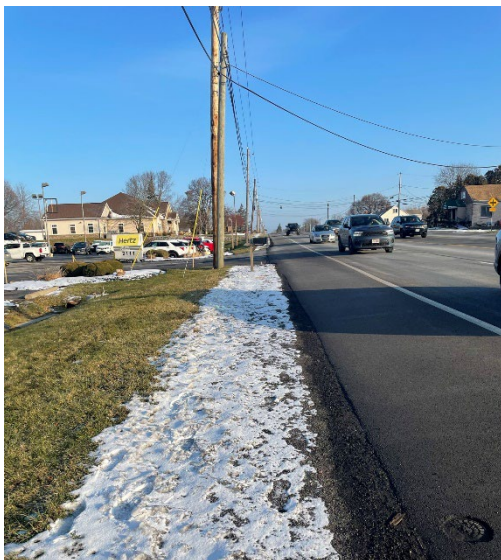
- There is an 8- 10 foot shoulder for the majority of the segment on the west side of the Empire Blvd and Gravel Road between Kirkland Drive and Cane Patch.

Shoulder on the west side of Empire

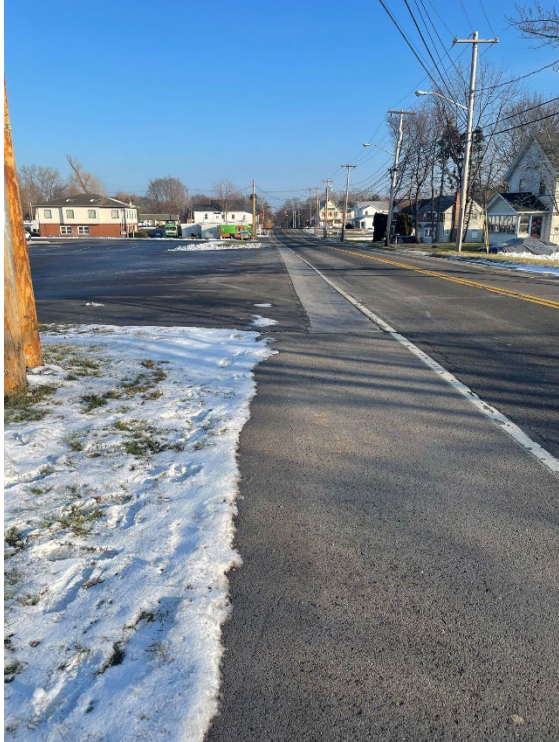
- The shoulder narrows to three feet as Gravel Road approaches Ridge Road and drainage grates and potholes are present in the shoulder.
- The West Webster Fire Hall on Gravel Road does not have sidewalks and has a large parking area with no controlled access points.

Driveway at the Fire Hall on Gravel Road

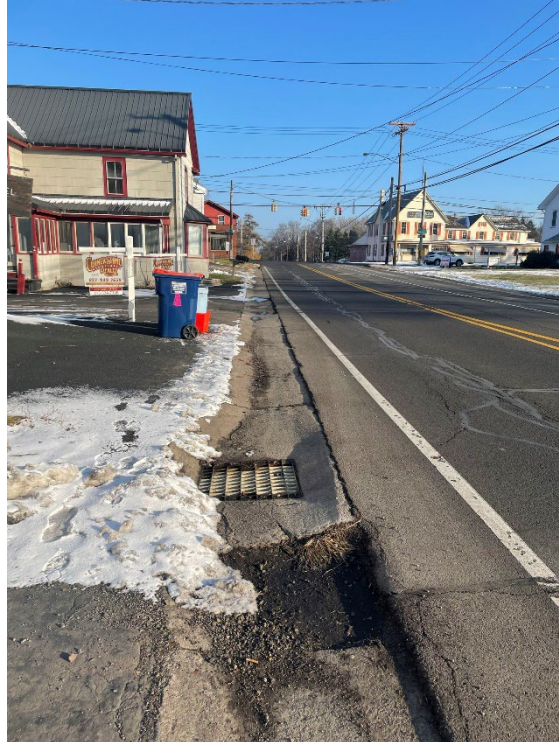
Shoulder on Gravel Road approaching Ridge Road

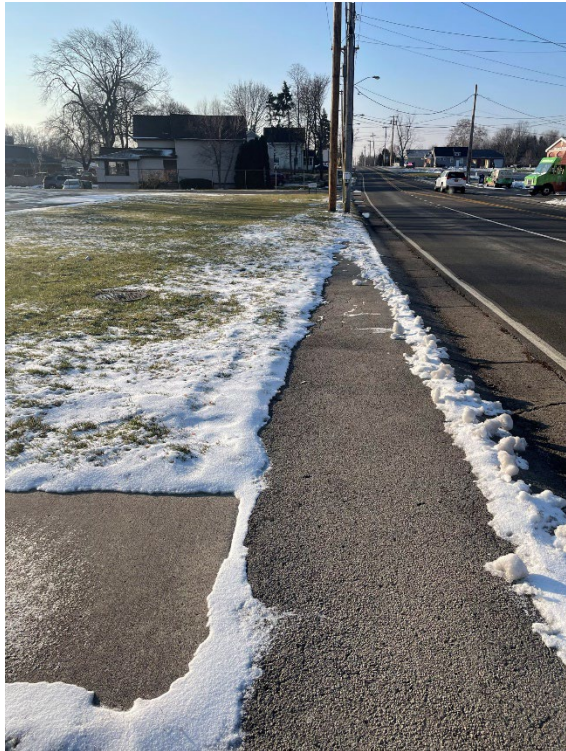
- There is a narrow asphalt path on the east side of Gravel Road heading south from Ridge Road, which ends after a short length.
- There is a 1-2 foot shoulder following the asphalt path on the east side of Gravel Road.

Asphalt path on east side of Gravel Road

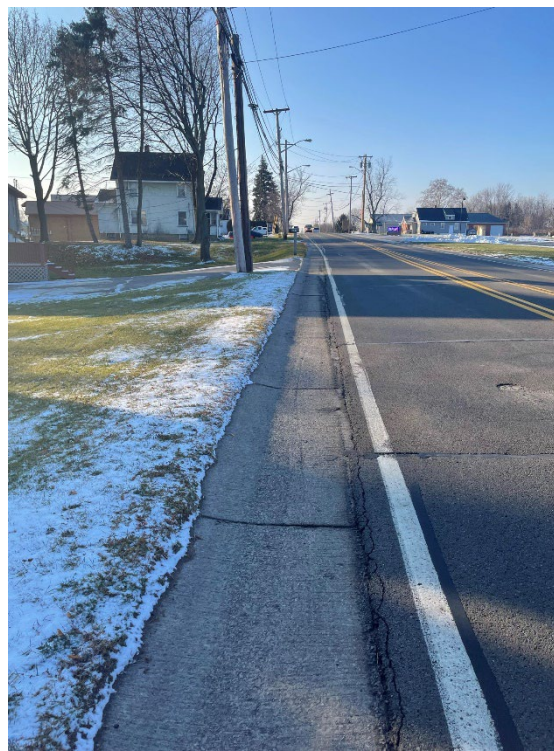
Shoulder on east side of Gravel Road
